LOSS

OF

CONTROL IN HUDSON

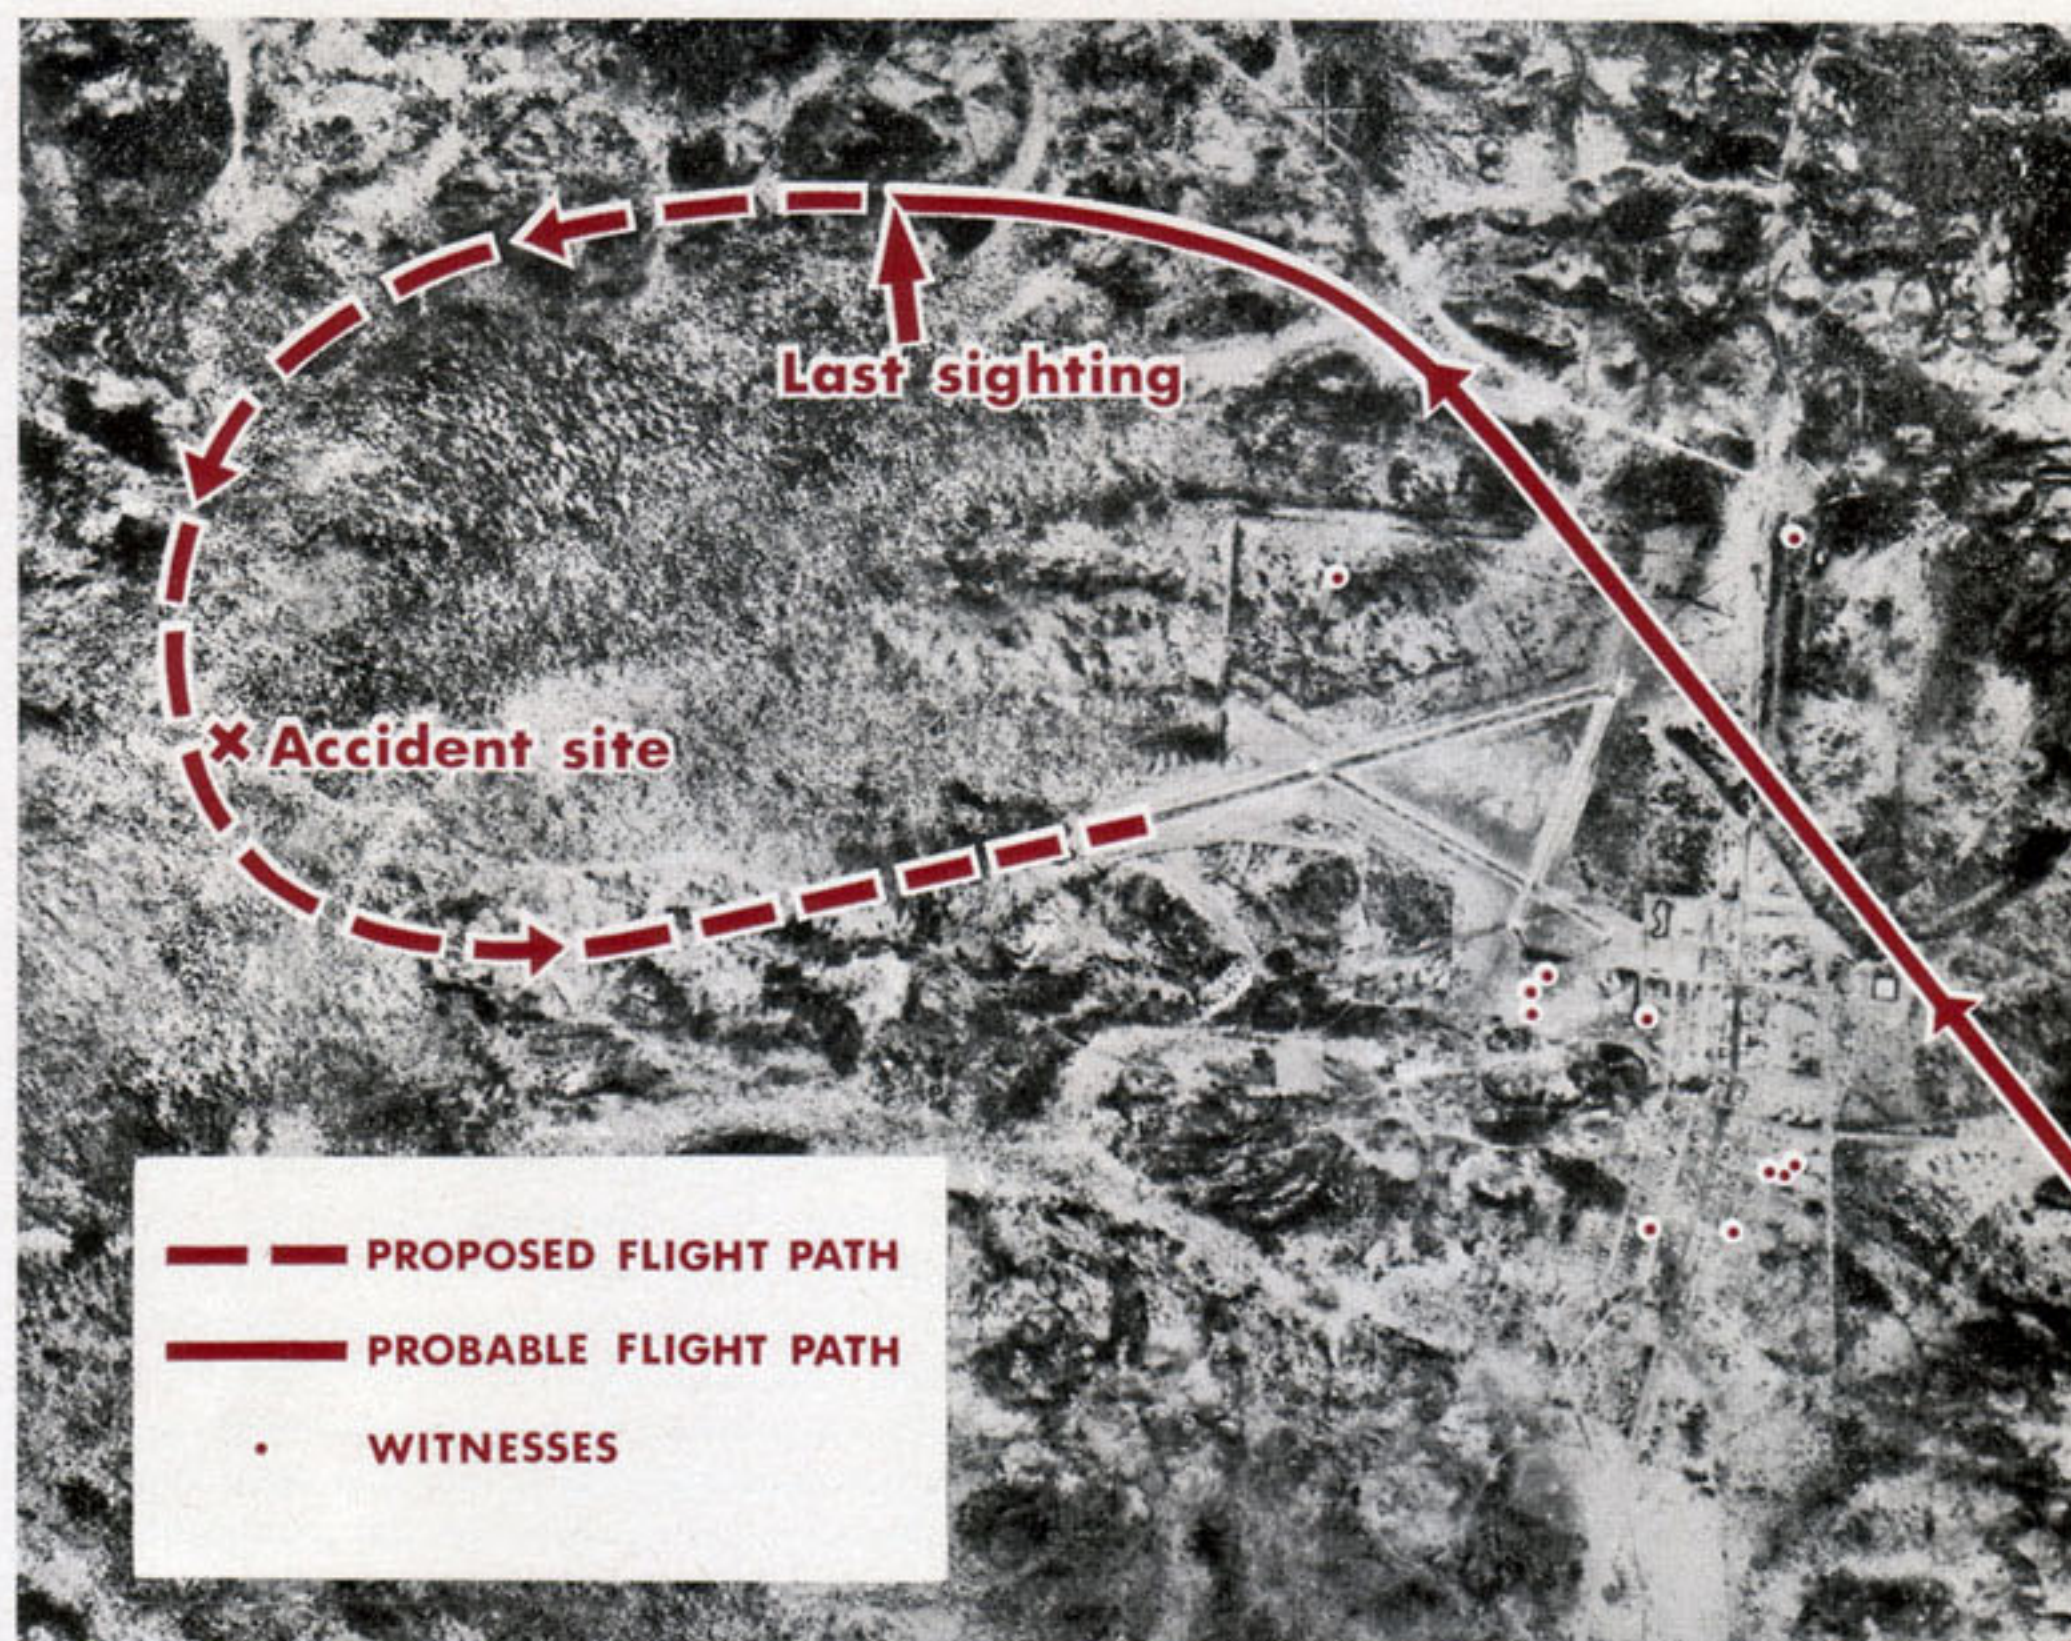
Aerial photograph of Tennant Creek area, showing township, aerodrome, final flight path and accident site.

There were no witnesses to the accident itself, nor could any be located who had seen or heard the aircraft flying other than normally. A number of witnesses saw the aircraft shortly before the accident and it was evident that, after approaching Tennant Creek from the south-east, the aircraft had passed over the eastern side of the aerodrome at 1,500 feet, lowered the undercarriage, and made a descending turn to the north of the aerodrome to enter a downwind leg for a normal left hand circuit and landing on runway 07. The crash site was consistent with a position on base leg, shortly before the aircraft would have

turned on to final approach. From evidence obtained from various sources, it was concluded that the aircraft had crashed at 0918 hours local time.

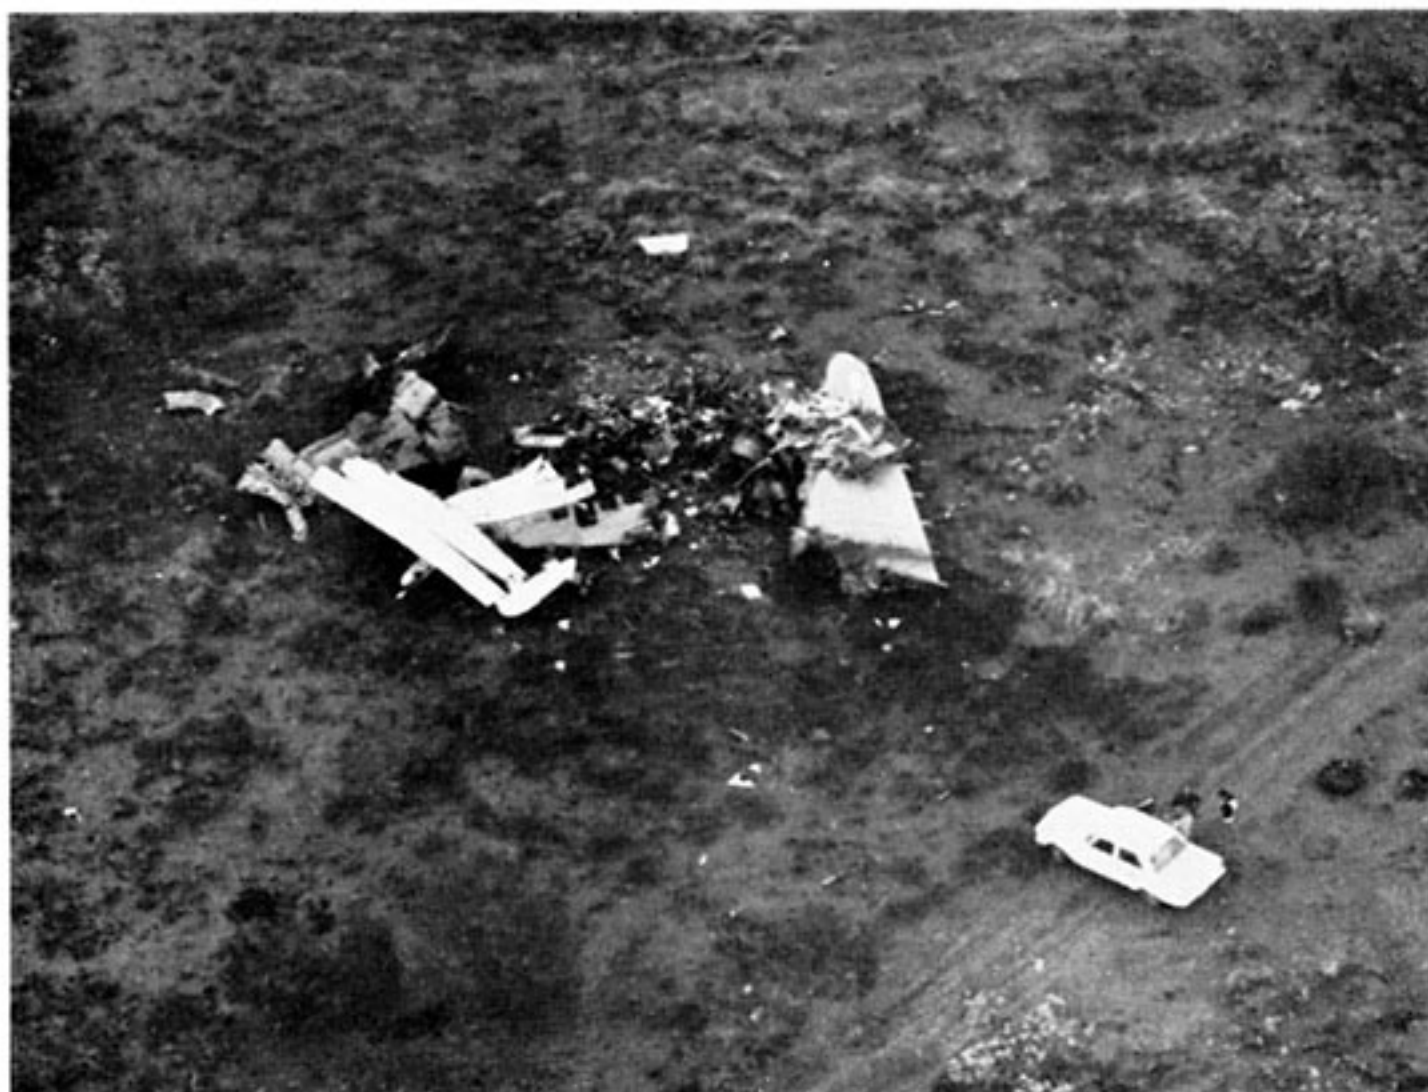
The aircraft appeared to have struck the ground at low forward speed and all major components of the aircraft were found in the area of impact. There was no evidence of any structural failure, fire or explosion which could

have affected the structural integrity of the aircraft in flight. It was established that the undercarriage was lowered and the flaps were retracted at the time of impact. The possibility of an asymmetric flap condition was investigated very thoroughly, but rejected. Both propellers had been rotating at impact, but neither engine appeared to have been delivering significant power. Examination of the engines themselves showed that they had been capable of normal operation up to the time of impact. All four fuel tanks had burst open at impact and their contents spilt, but examination of the fuel system revealed nothing to suggest that fuel would not have been available to the engines. The engine magneto switches were on, selected to the "Both" position. Although the master ignition push-pull switch was on, it was not possible to determine if the switch was in fact in this position at impact. Because of the extensive damage and possible movement at impact, the positions of the throttle mixture and pitch controls could not be established, but the firewall shut-off lever for the starboard engine was in the closed position, and it was evident that it had been moved to this position before impact. This indicated that although the engines were capable of normal operation, some action might have been taken to shut them down immediately before impact.

The most significant finding to emerge from the examination of the wreckage was that one of the duplicated aileron control chains in the pilot's control column was broken in the region of the control wheel sprocket. The breakage had occurred when a link pin of the chain had failed, and there was evidence that the broken link pin could have subsequently jammed the assembly as the control wheel was being rotated. Following further extensive examination and laboratory testing, it was concluded that the failure of the chain and the associated damage to the control column assembly, were not consistent with impact damage, but the investigation could not positively establish

Aerial view of the wreckage. The initial point of impact is at the extreme left of the picture.
