***Amana* – One Small Piece of Jigsaw**

By Grahame Higgs July 2007

Four Engines Out

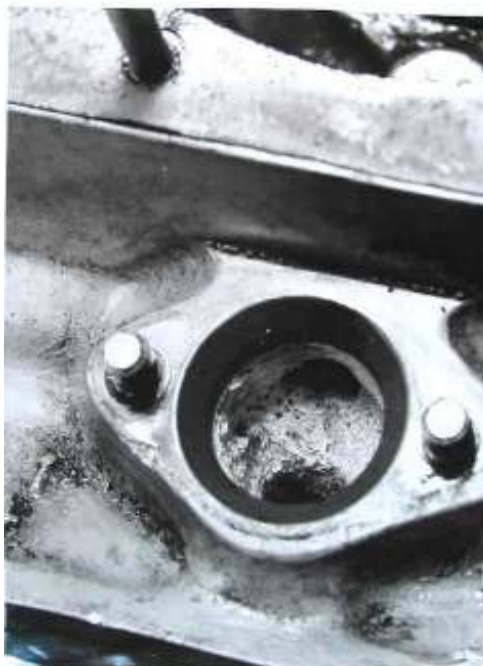
The air accident investigation team learned that despite refuelling several times, most of *Amana*'s fuel tanks had not been checked for water contamination since she had left Sydney early that morning. This fact, along with corrosion found in the number one engine fuel passage intake, (below) led the investigating team to pursue a "water in the fuel" theory. However, there was another explanation.

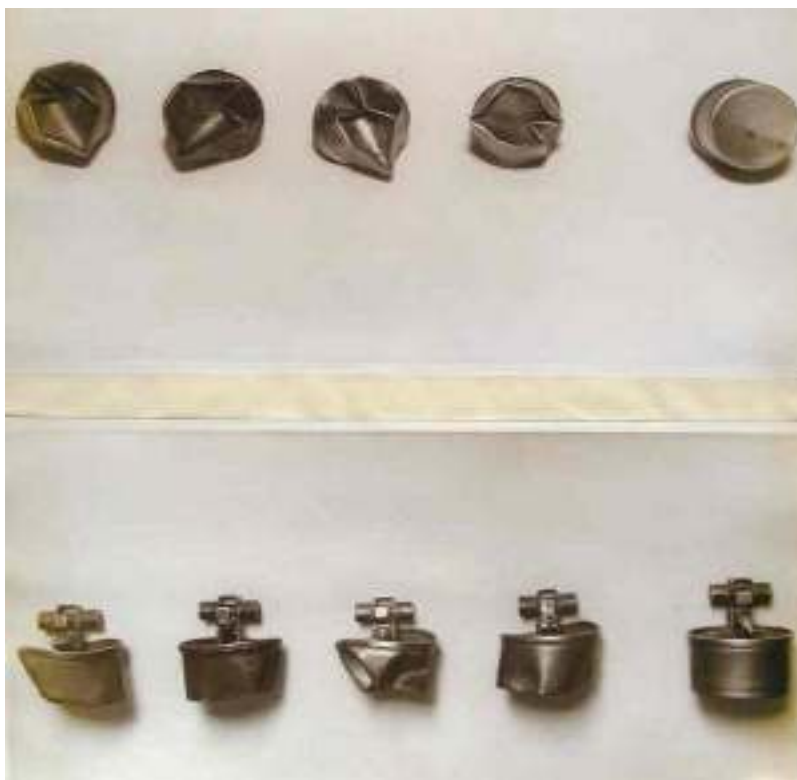
In their findings the investigators were not able to determine the source of the intake corrosion, nor were they able to explain the circumstances that caused an unusual crushing damage to the vapour vent floats in the strainer chamber of all four engine carburettors. This damage was described by the investigating team as being the result of "surge pressure". However, despite the best efforts of engine manufacturer Pratt & Whitney, the Australian Research Laboratories, the Department of Civil Aviation and the US Civil Aviation Authority, none of these respected institutions could identify what caused this "surge pressure", which remained one of the most perplexing of *Amana*'s mysteries.

Amana's damaged Vapour Vent Floats compared to a serviceable unit on the right.

And finally, could the shock of the explosion have triggered a momentary intense pulse of high pressure into the fuel lines, the “hydraulic” effect of which caused the vapour floats to crush as the over-pressurised fuel

was forced through the vapour vent? In other words could this be the source of the investigating team's "surge pressure"? Without a small scorched piece of *Amana* jigsaw the best brains on the job in 1950 had only the Inkpen and McNamara testimony to even hint of this as a possibility.

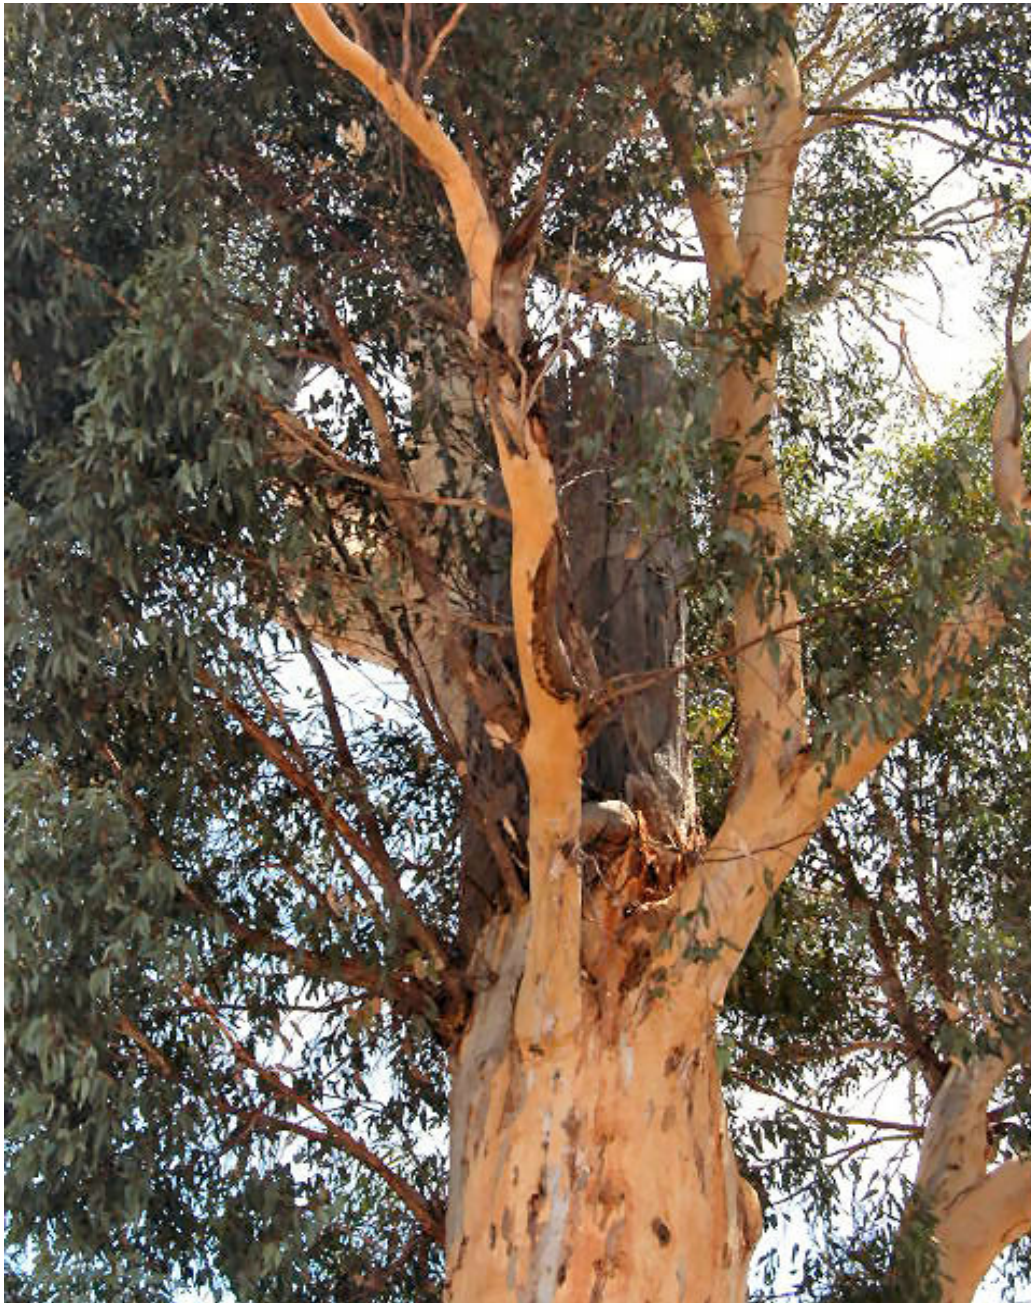
Despite years of cultivation, the signs of an aircraft accident are still there. Consider this tree for example, sheared off by *Amana* some 30 feet from the ground just prior to impact.

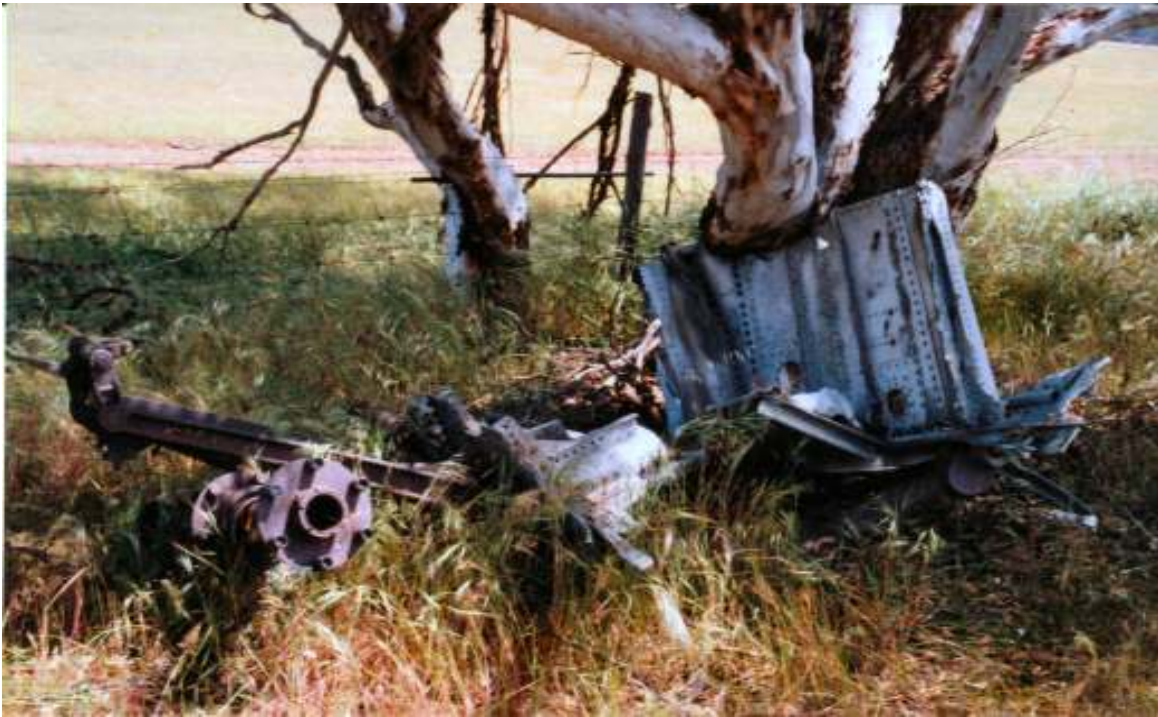
Even more graphic are the unmistakable remains of the port undercarriage.

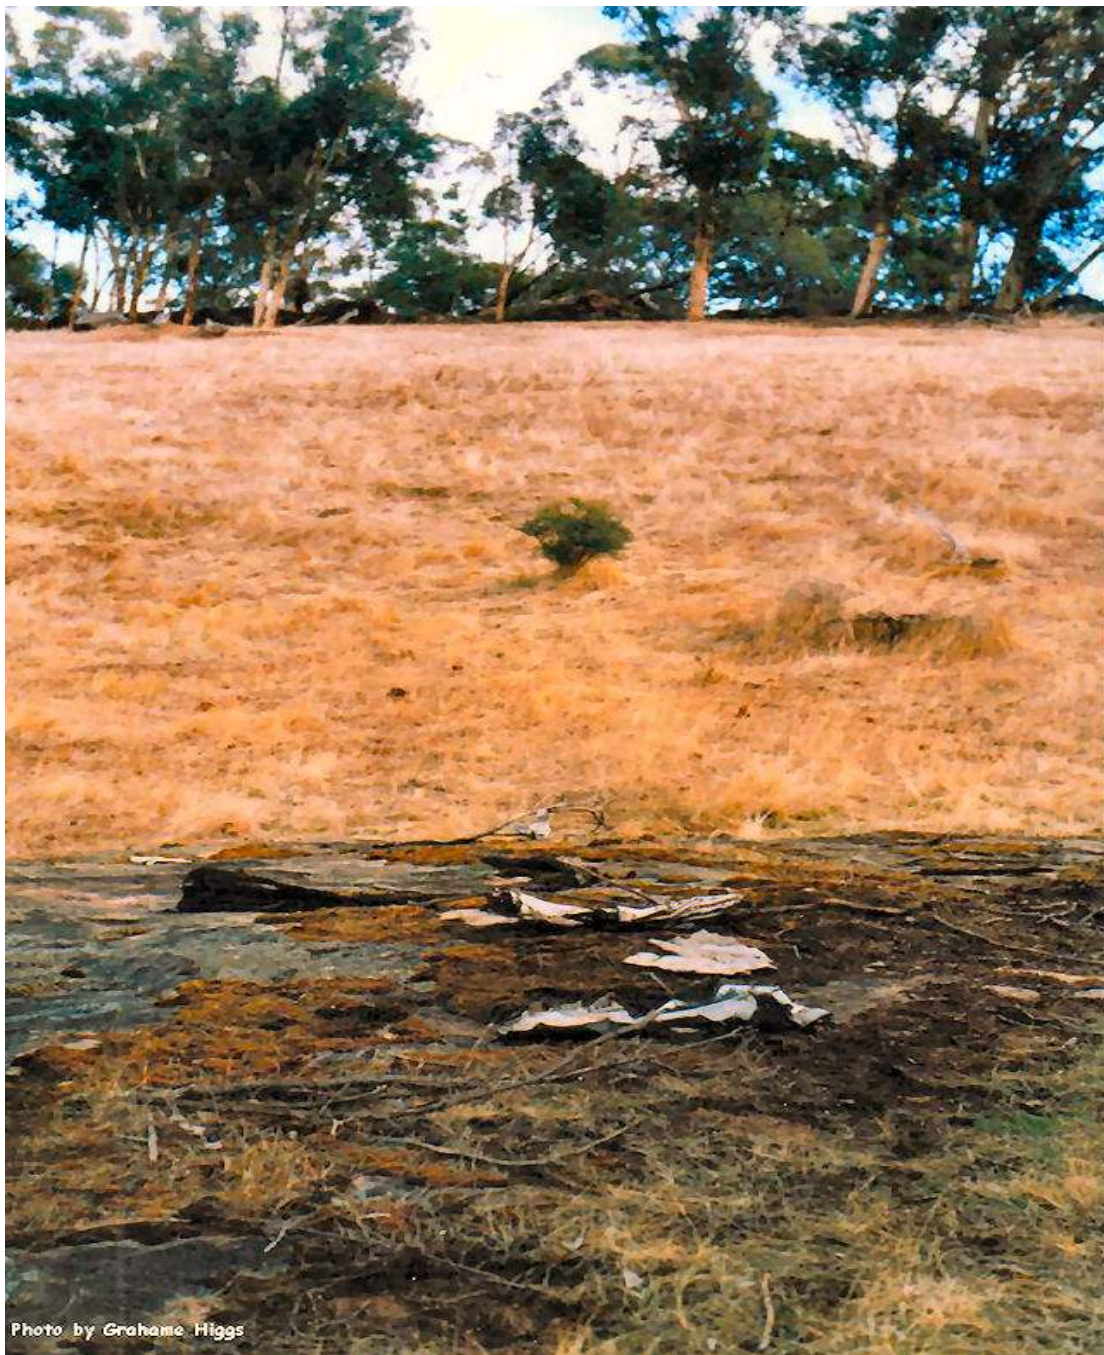
The "new wreckage" in-situ.

There were five main pieces of *Amana* and a couple of smaller bits, all of which appeared to have been tossed onto a rocky outcrop when the small area around a nearby hill had been cleared for pasture many years previously. This was indeed fortunate because it had saved the wreckage from any bushfires that may have swept through the area.

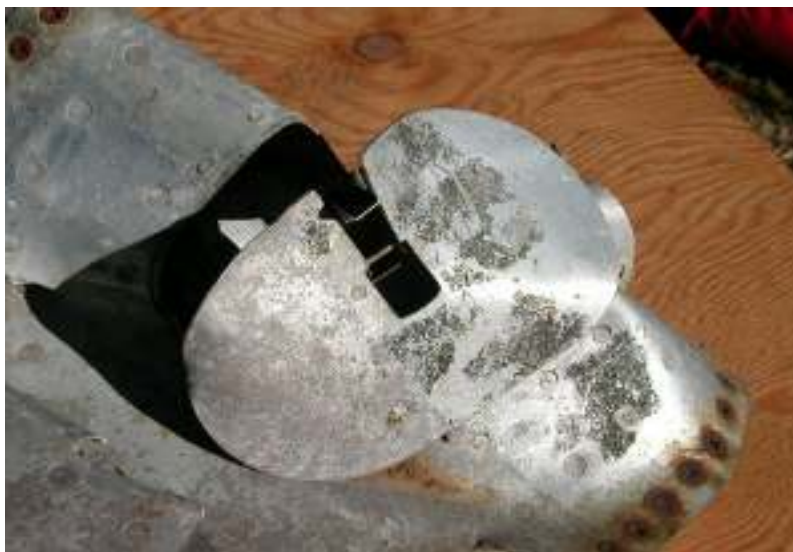
The first piece we considered was quite startling to see. It consisted of some crumpled heavy-gauge alloy that, remarkably, contained a complete inspection hatch with a distinctive shape and latch design.

The inspection hatch and the area around it bore traces of black paint with distinct edges, paint that was quite rough to the touch, something akin to an anti skid walkway on the wing. However, it made no sense to have a walkway over a fragile inspection hatch so the reason for the black paint initially remained unresolved.

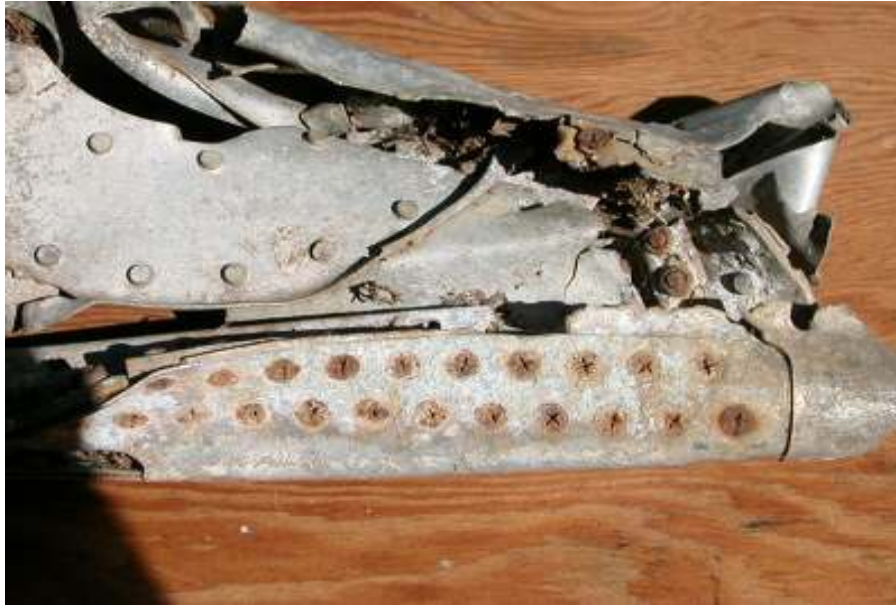
The “hatch” piece was also distinguished by having a double row of screws along one edge.

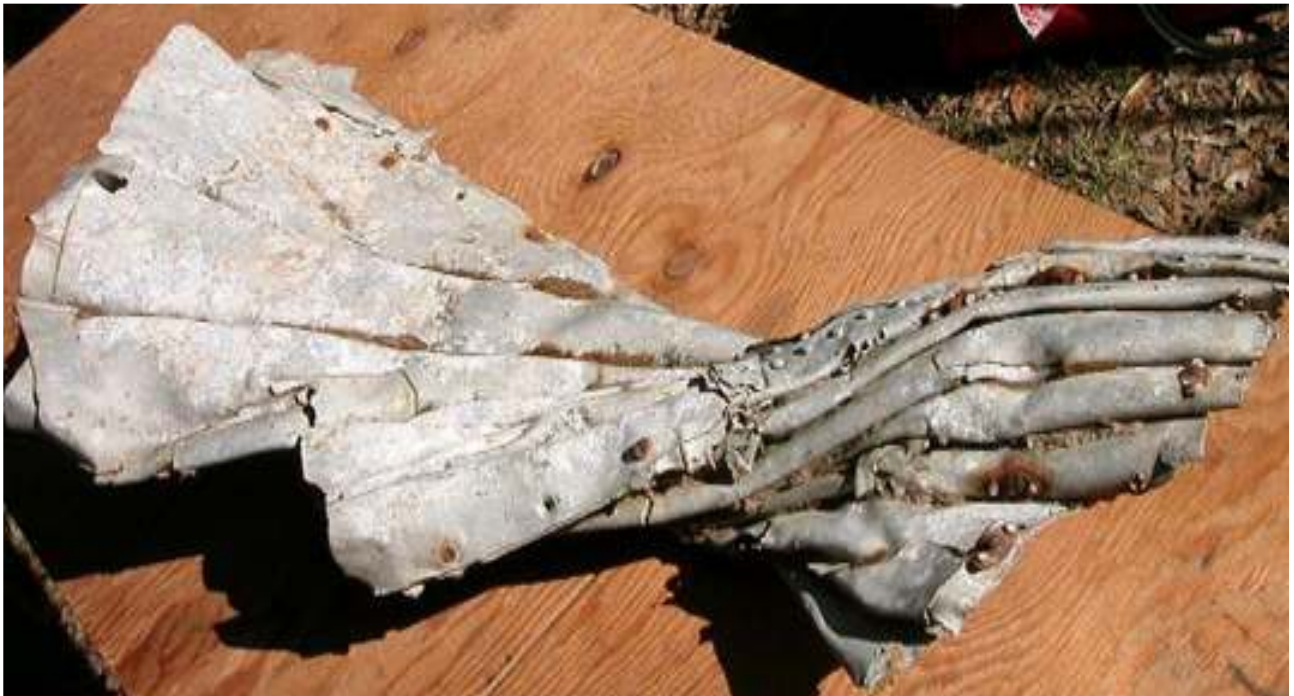
The second piece, named the "Bow Tie" piece, is also of a heavy-gauge alloy that appears to have been folded "fan like" before being twisted off the aircraft.

Given the weight of this piece of wreckage, the gauge of aluminium and the traces of black paint, this is thought also to be a piece of wing skin, possibly (but not confirmed) from ahead of the inspection hatch piece towards the leading edge.

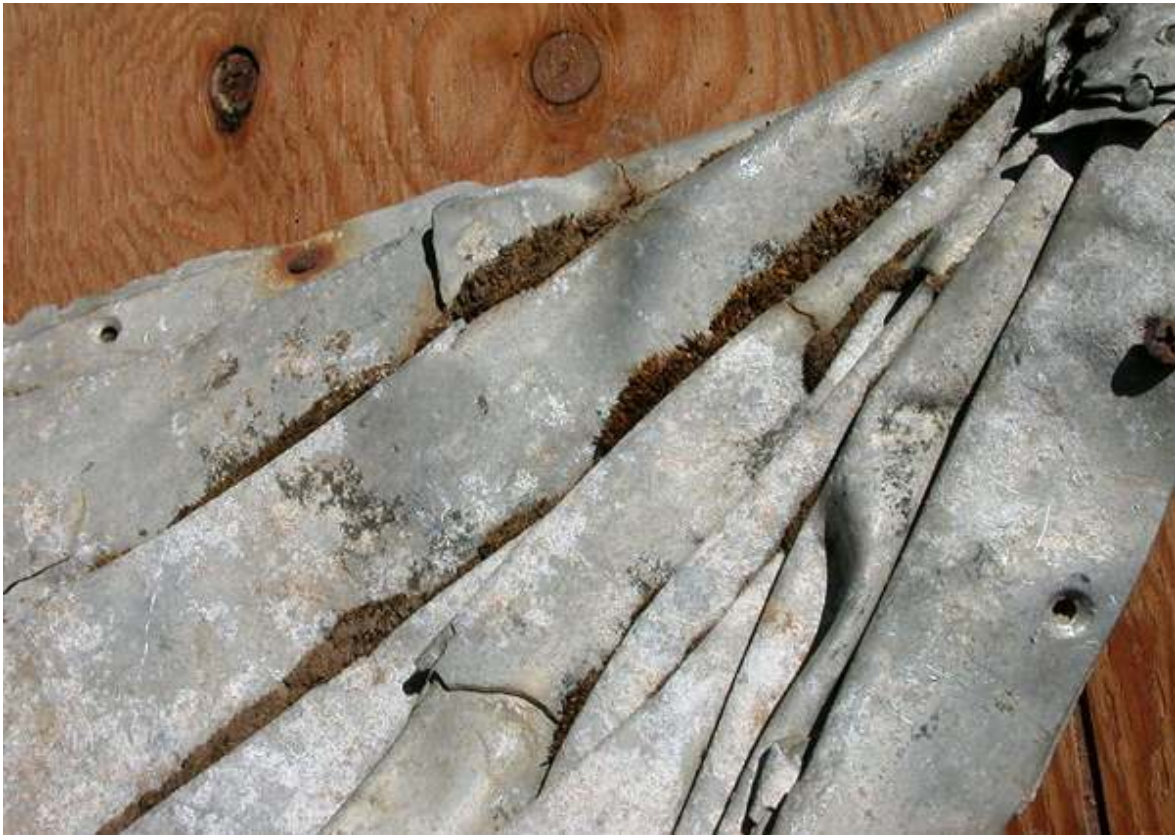
It also shows traces of black paint on one side, established as being an external surface by the position of countersunk screw holes and screw heads.

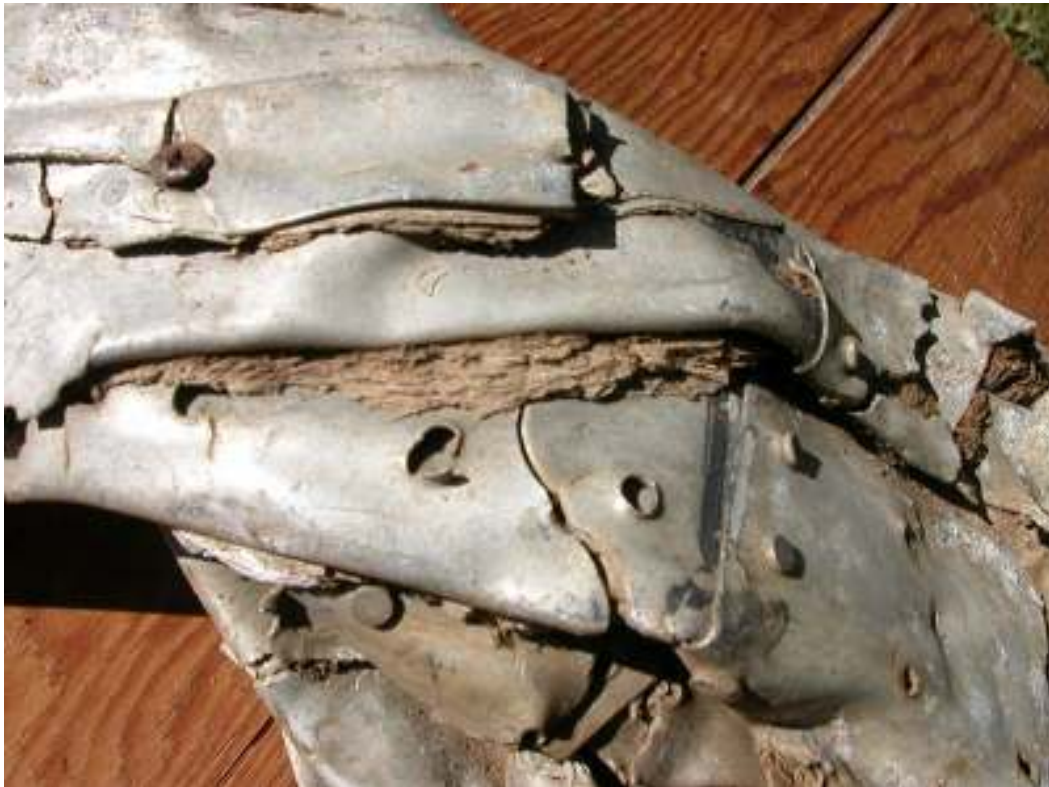
On the inside surface it has a significant quantity of Mica trapped in the folds of the concertinaed “fan like” damage. The purpose of the Mica is yet to be determined.

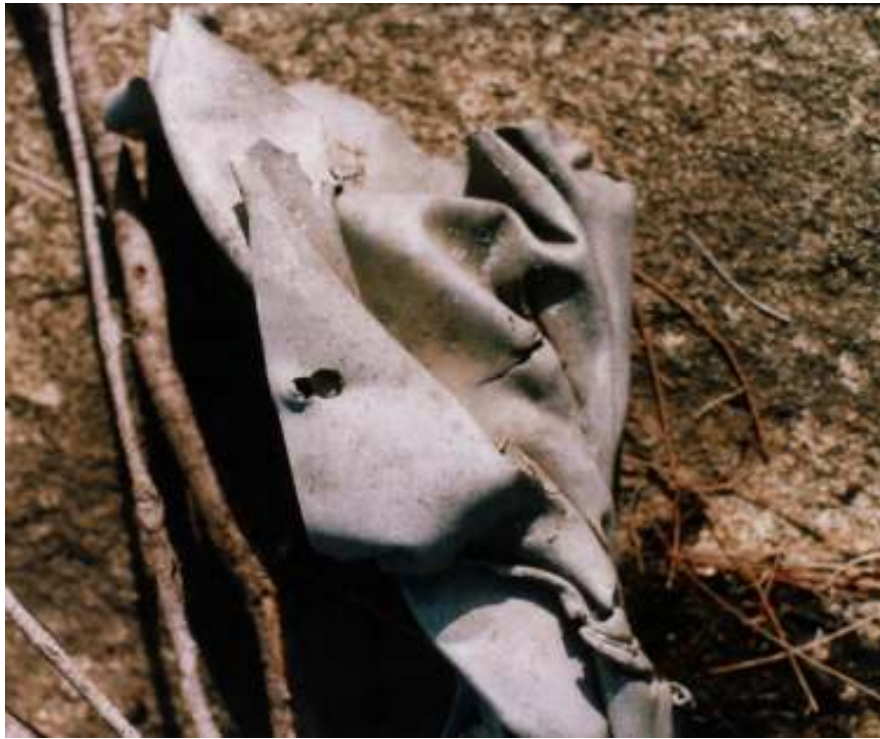
The third bit of wreckage, a small piece of the jigsaw, much less imposing than the previous two, proved to be the most interesting and revealing.

Made of much lighter-gauge aluminium than the wing skin wreckage, the third piece had a clear scorch mark across one face. Significantly, the scorch mark was uniform throughout the creases and wrinkles indicating that whatever the event that caused the burn mark, happened before the piece became crumpled. The other side of the wreckage showed no sign of being burnt. Were we just lucky or was it more than pure coincidence that on an edge of the wreckage, a solitary screw head remained trapped by a fortuitous fold?

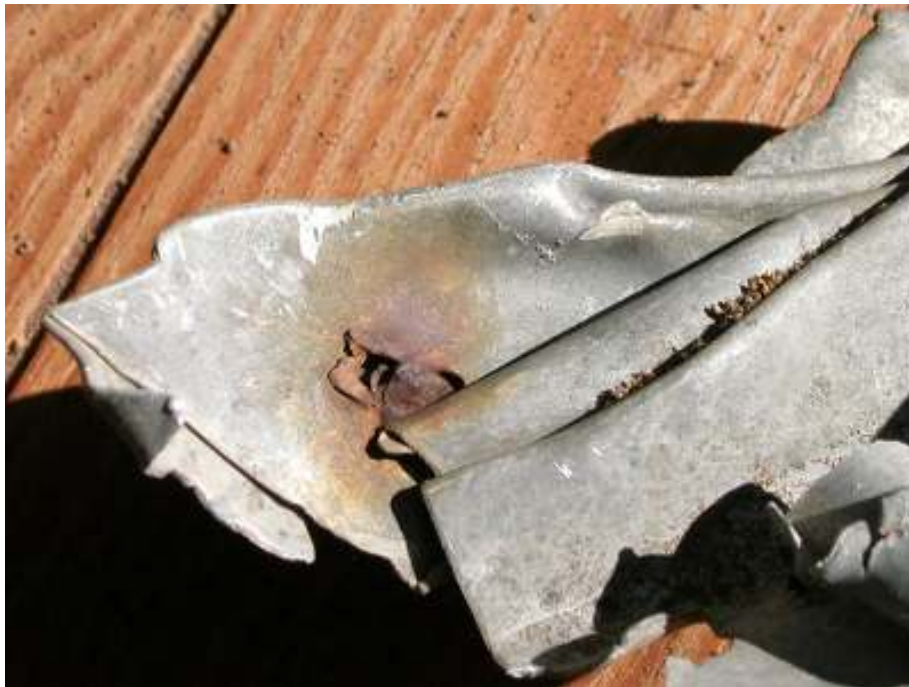
The shank of the screw protruded into the burnt face, while the head rested against the un-burnt face. This told us that the burning process took place **inside** what ever this once was when intact.

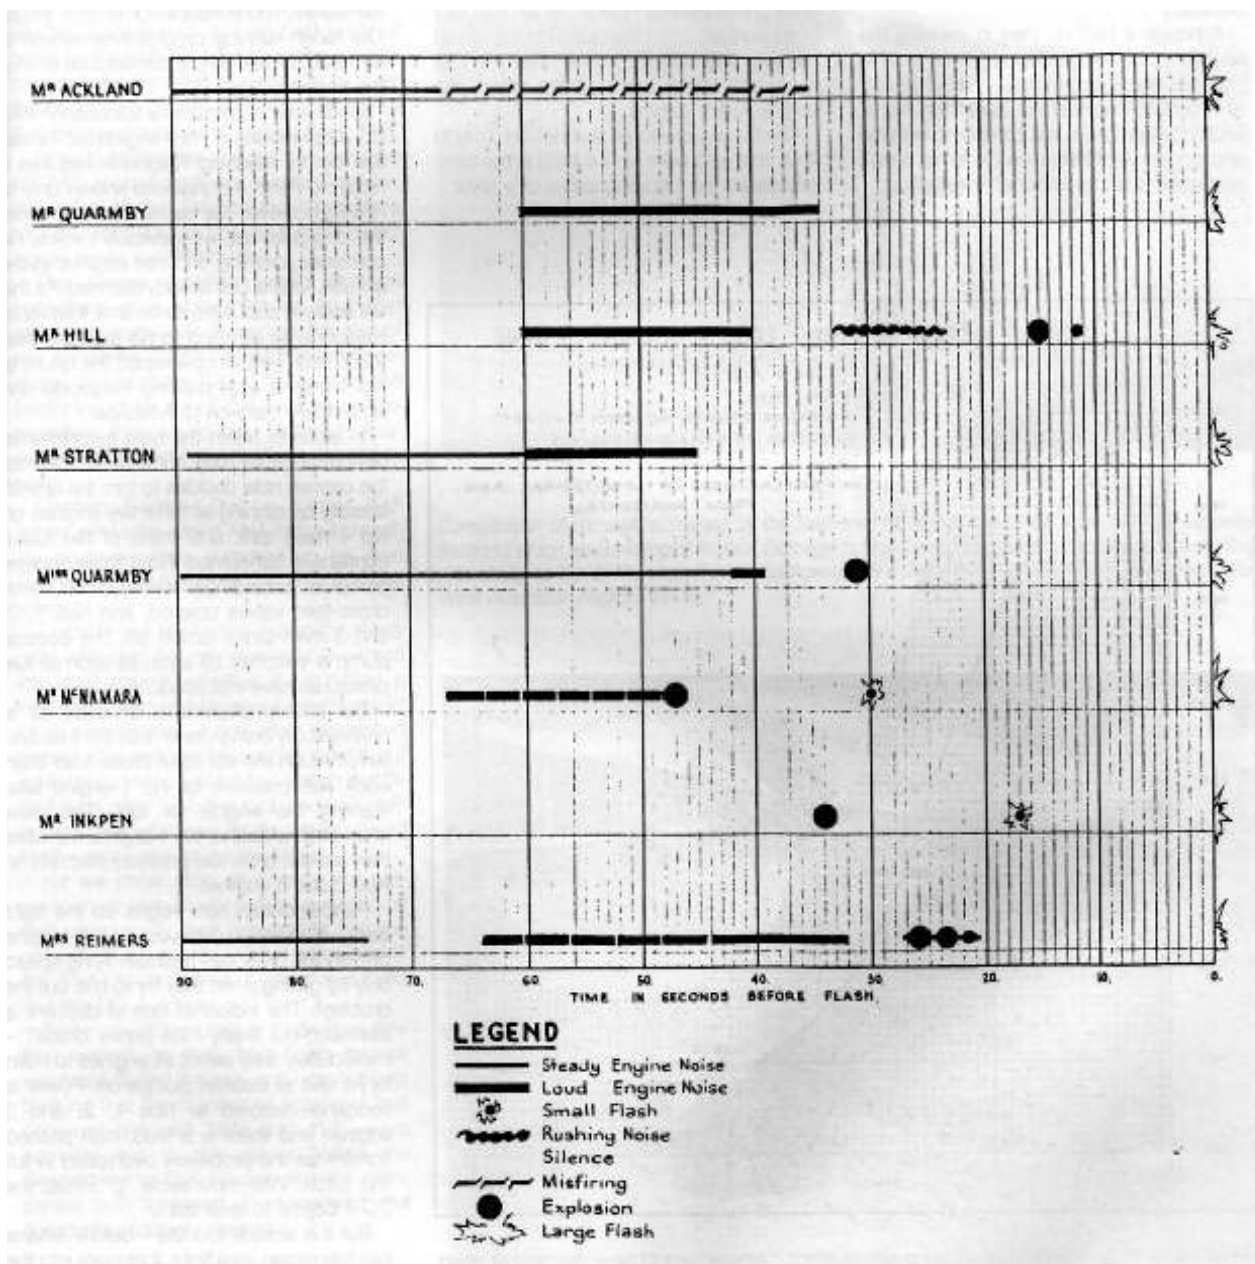
During the original accident investigation, five witnesses reported an explosion and, of those five, farmer R. Inkpen and beekeeper L.B. McNamara also reported seeing a small flash some 20 to 30 seconds prior to an enormous flash that lit the night sky.

Diagram prepared by investigators graphically comparing evidence of witnesses in locality of accident. (BAS)
