***Amana* – One Small Piece of Jigsaw**

By Grahame Higgs July 2007

Four Engines Out

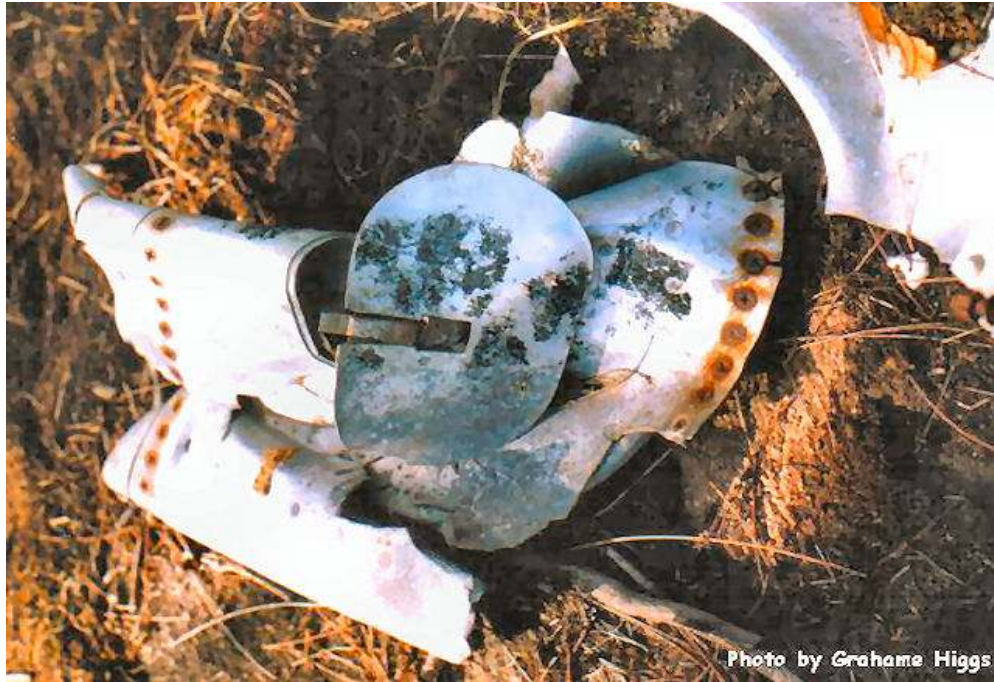
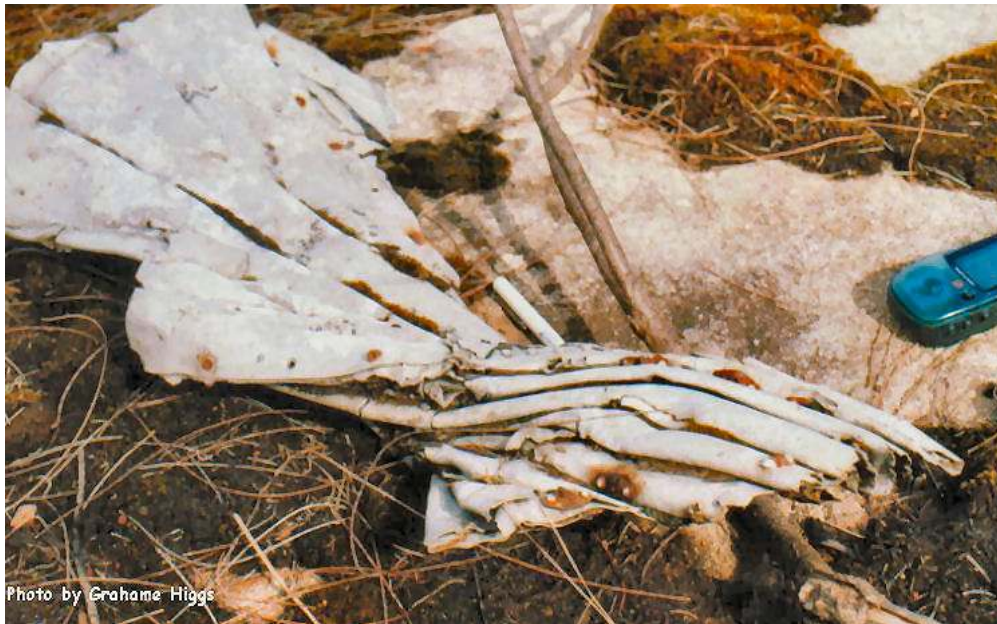
A couple of the pieces seen below, as discovered, were particularly intriguing.

Obviously, if my sub-conscious was ever going to grant me another peaceful night's sleep, there was a need to find out what part of the aircraft they were from and how they came to be so far from the main crash site.

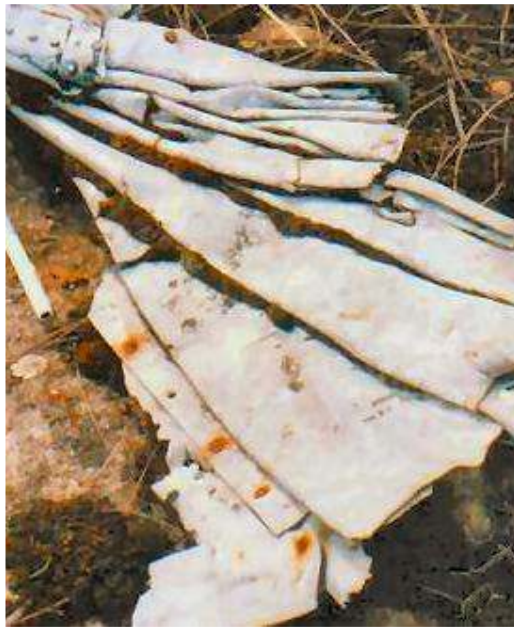
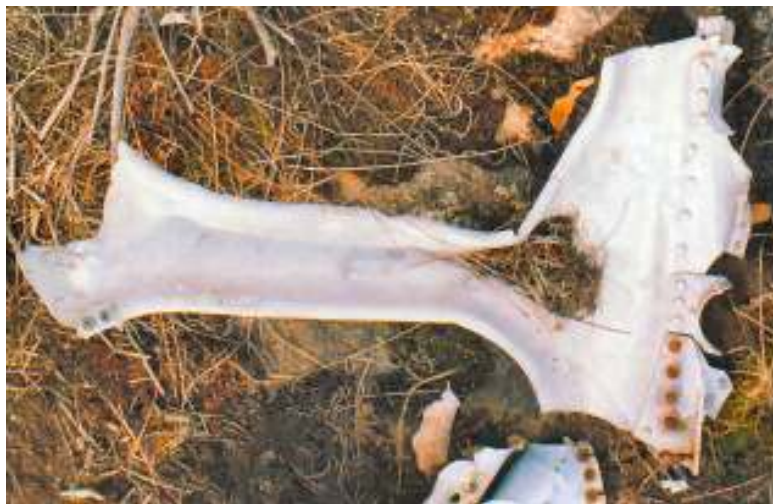
Typically, to find wreckage at some distance from the crash site it is reasonable to assume that it came off the aircraft in flight prior to the final event. Although the wreckage had some 50 years to migrate from the crash site to where it was found, there was no watercourse to carry it, no bush track or thoroughfare that would suggest that someone had chosen to dump the wreckage on that spot having become tired of carrying it, nor was there any evidence to suggest that the wreckage had been anywhere else in the previous five decades. In fact the moss growing in the folds and the organic debris that had collected in the concave sections suggested that the wreckage had been there for some considerable time.

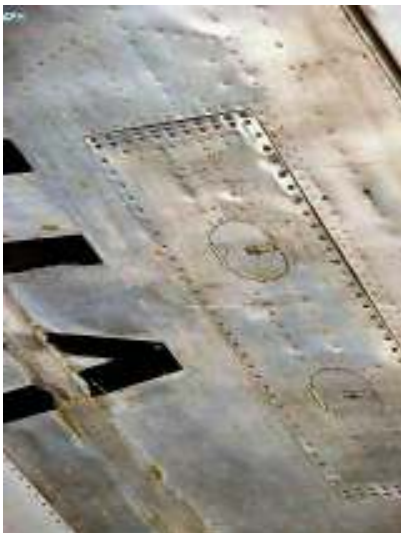
Port Wing

The port wing panel was about mid span between number one engine and the wing tip, between the third and fourth aileron hinges, while the starboard panel was closer to the number four engine nacelle opposite a notch where the aileron and flap abut. They both had the correct double screw edge and hatch/latch shape and orientation, so which was our piece? What we needed was a good under wing photo of *Amana*.

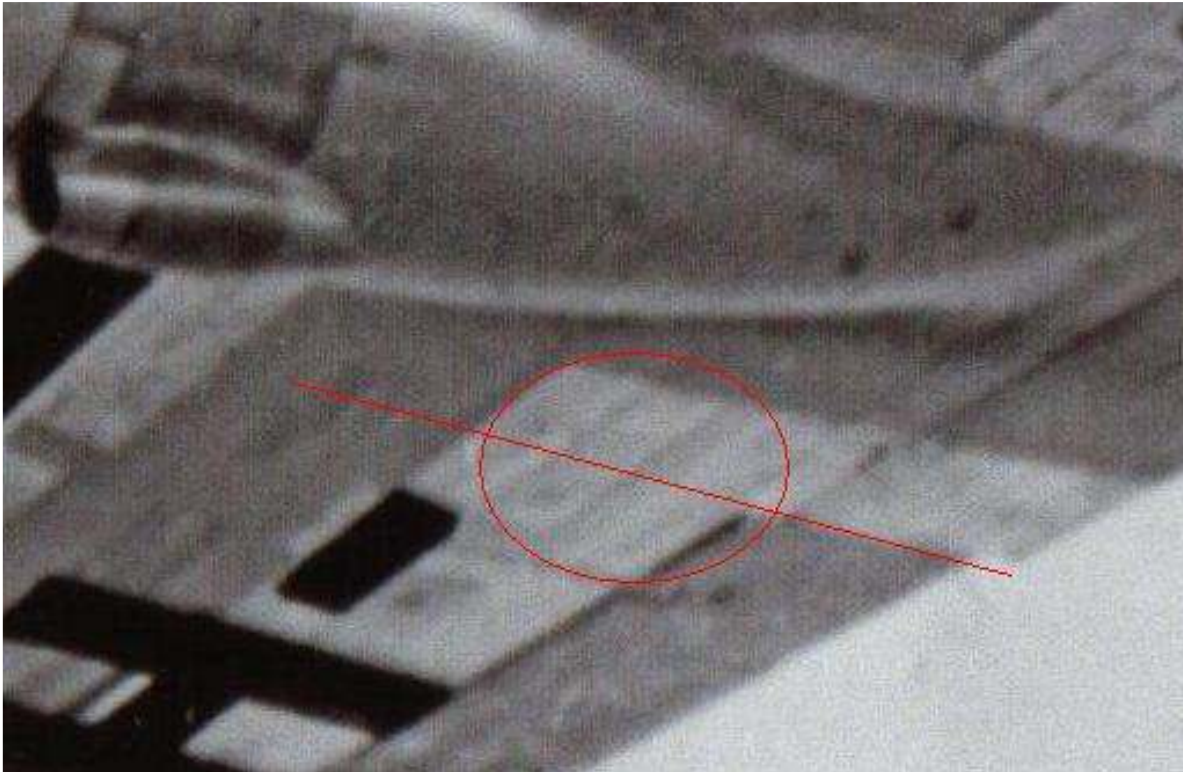
Notice that the starboard wing opposite the aileron/flap notch is bare aluminium.

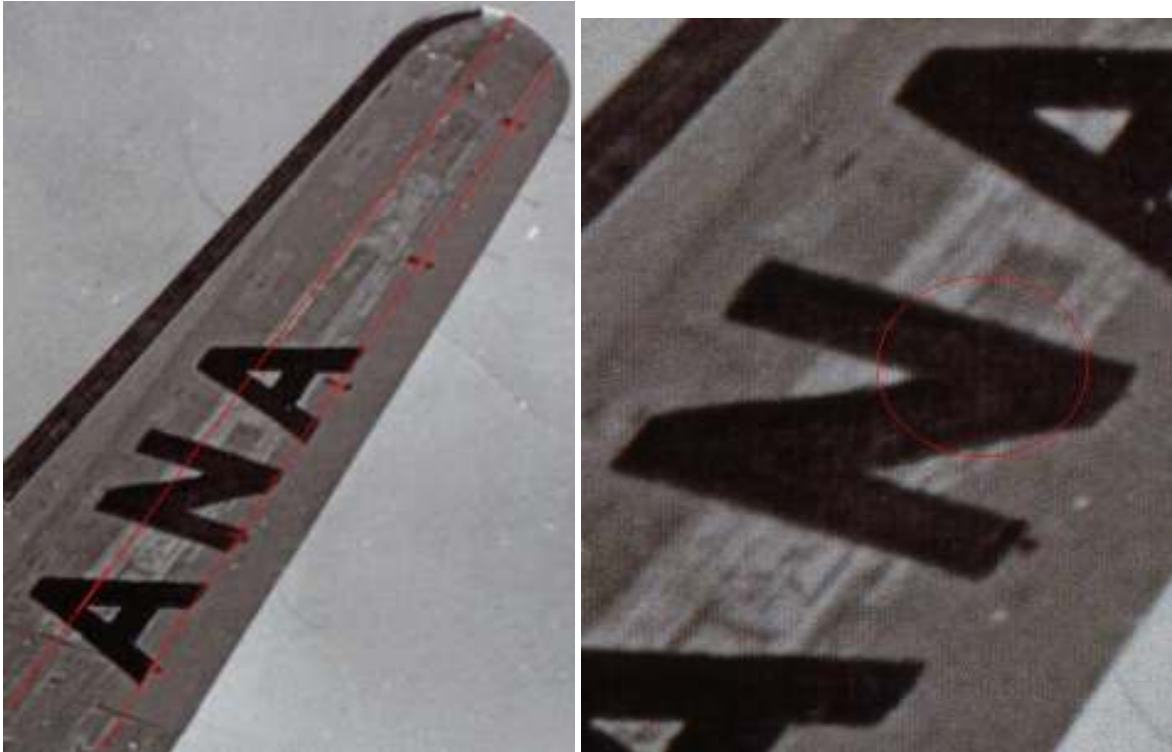
While the port wing between the third and fourth aileron hinges (counting from the wing tip inboard) proudly sports *Amana's* registration letters "ANA".

Thus we concluded that our first piece is from the under surface of *Amana's* port wing and that the black paint is part of her registration.

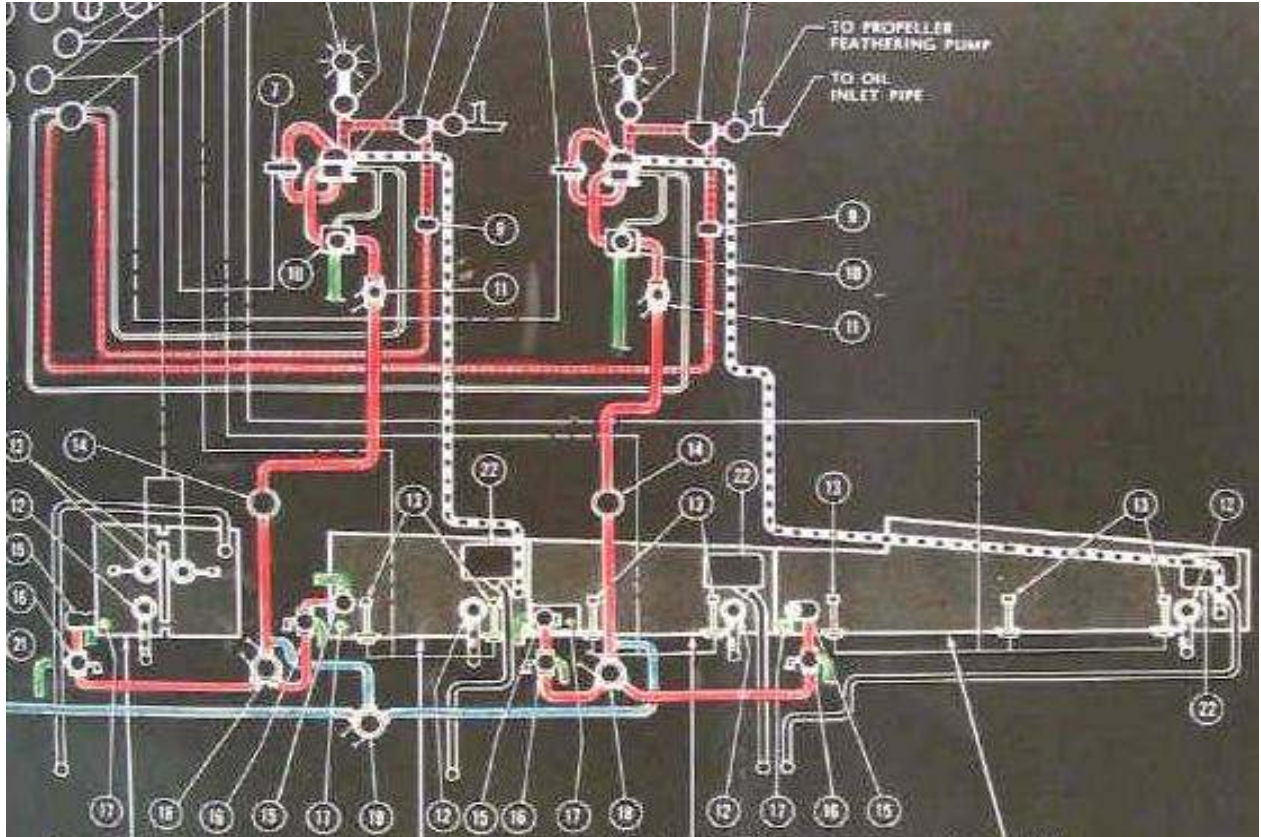
Knowing where the inspection hatch piece had come from we felt it was reasonable to postulate that the scorched piece also came from the same general area on the wing. Reference to the fuel diagram for the DC-4 revealed that in the area that the inspection hatch came from, the wing housed the main fuel tank for number one engine.
